CAD -269- DEPARTMENT OF ENVIRONMENT AND NATURAL RESOURCES - REGION III

DESIGNATION: BLLM No.197

STA. ROSA CADASTRE

CONTROL POINT

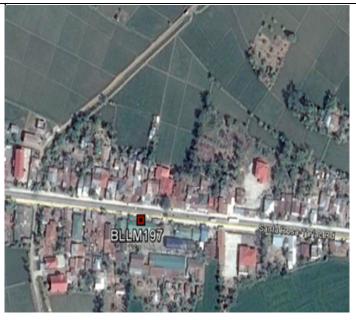
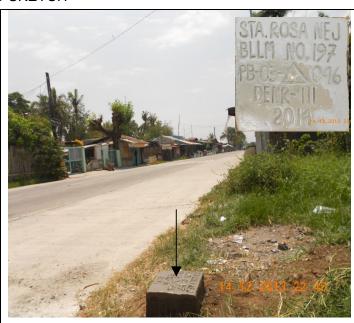
PHOTO / SKETCH

Mark is the head of a 3" copper nail embedded and centered on a 25X 25cm (top) by 35X35cm(base) by 120cm(height) standard concrete square base frustum, set on the ground with protruding 20 cm on the surface with inscriptions..."STA.ROSA NEJ BLLM NO.197, PB-03-000046 DENR III 2014".

The monument is located along the Sta.Rosa-Tarlac Road in Brgy. Santo Rosario in front of Santo Rosario Elementary School.
